The Peter Miller House
422 South Loudoun Street

The Peter Miller
House

Front and Rear
August
1980

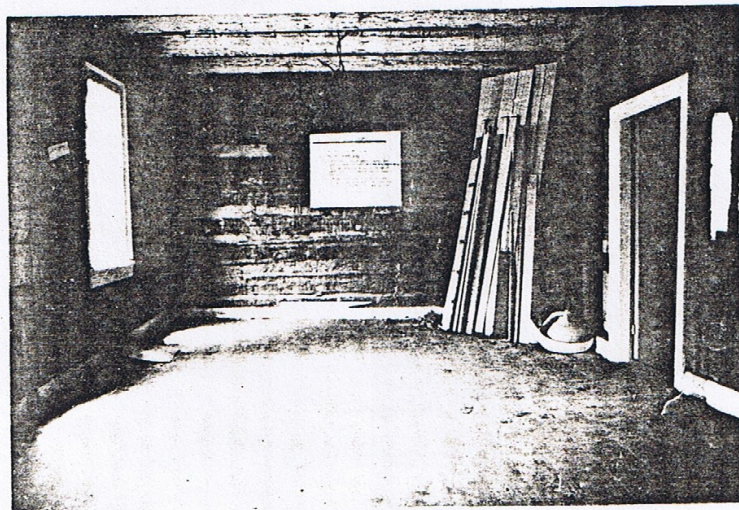
North wall of
the living
room.

The chairrailing in the living room was salvaged from throughout the first floor rooms and is all that remains of the original. The Carpenter Locks were removed and rebuilt by Ball and Ball of Whitford, Pennsylvania. The bookshelves along the north wall were installed by the present owner and will have a six panel door put on the center section. The design concept for these shelves was to carry the baseboard and chairrail across the wall with paneled doors below and open shelves above. However, a two and a half inch difference in the level of the floor prevented doing this.

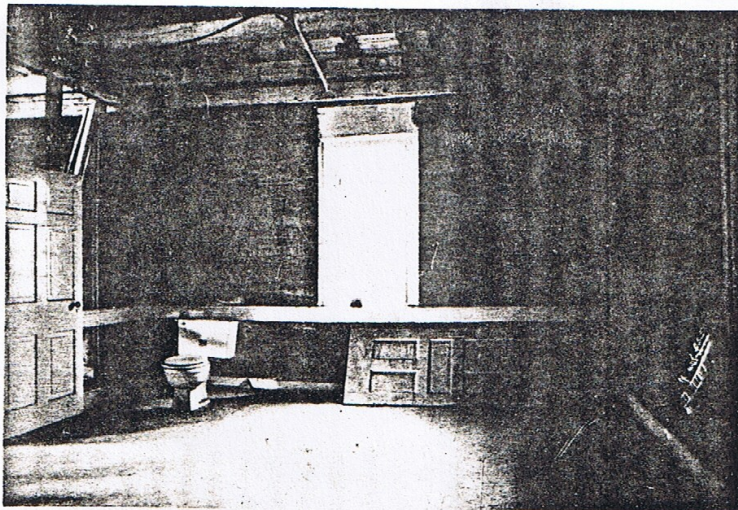
North wall of the dining room, where the storage and Bar closets are.

The front walls of the storage closet in the dining room (next to the corner cupboard) and the Bar closet will have paneled walls installed on them with their respective doors worked into the panneling detail. The mantel for the dining room fireplace came from a house in Leesburg, Virginia as well as the one for the fireplace in the master bed room above.

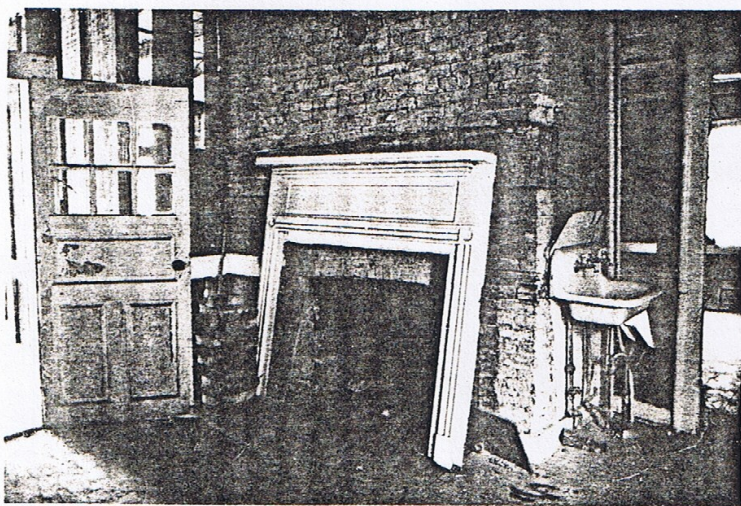
Kitchen fireplace before reopening.

In addition he reduced the size of the opening of the kitchen cooking fireplace (leaving the wood lintel where it is) to a standard size and then opened a new fireplace in the dining room, with both fireplaces sharing the old kitchen fireplace flue. This flue was adequate enough, after some minor modification, to reopen the kitchen fireplace to its original size and retain the fireplace in the dining room.

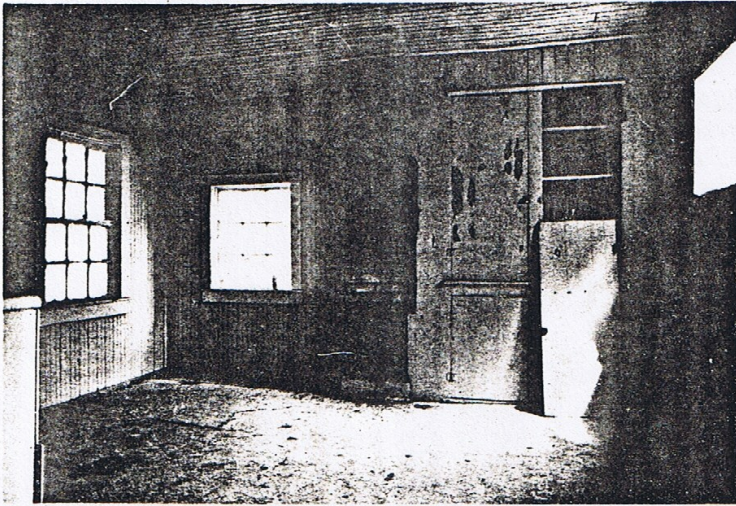
Looking into the
lean-to addition
from the kitchen.

The purist soul wanted to remove the lean-to-addition, but the Welsh soul won out, for as we'd paid for it why not use it as a part of the transitional fabric? Ommitting it would have necessitated the labor to take it down and haul it away as well as the construction costs for a porch to cover (a new) exterior basement entrance for access to the furnace, hot water heater, washer-drier and freezer, with a half bath where the cellar stairs are now. As it is this wing provides the desk space; that for a washer-drier and freezer (after the logs have been cleaned and re-chinked) and for the existing half bath and furnace room, using the old cook stove flue for the furnace and hot water heater.
