City of Winchester

219 South Kent Street

DHR Resource Number: 138-0042-0539

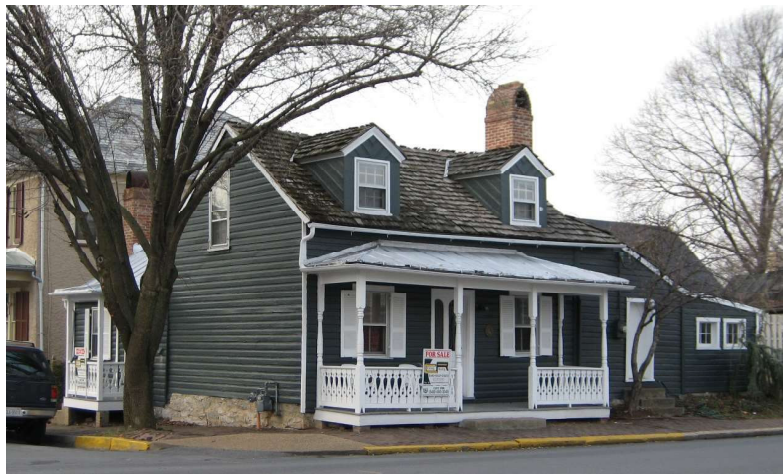
Primary Resource Description: This one-and-a-half-story, three-bay single dwelling is set on a solid foundation of uncoursed stone. The log dwelling is clad with German wood siding and has wood corner boards. A large exterior-end, brick chimney with an arched hood rises from the side (north) elevation. The side-gabled roof is covered with square-butt wood shingles and features two front-gabled dormers. The dormers are clad with diagonally placed, beaded wood siding and contain 6/6, double-hung, wood-sash windows with narrow wood surrounds. A one-story, three-bay porch stretches across the façade. Set on a brick pier foundation, the porch has a balustrade with sawn balusters and a half-hipped roof of standing-seam metal that is supported by turned wood posts. The window openings on the façade contain 2/2, double-hung, wood-sash windows with narrow wood surrounds and operable, louvered wood shutters. A single-leaf, paneled wood door with narrow, half-round lights pierces the center bay of the façade. The side (south) elevation is fenestrated by a 6/6, double-hung, wood-sash window in the upper gable end.
