# City of Winchester

## 201 North Loudoun Street

DHR Resource Number: 138-0042-0629

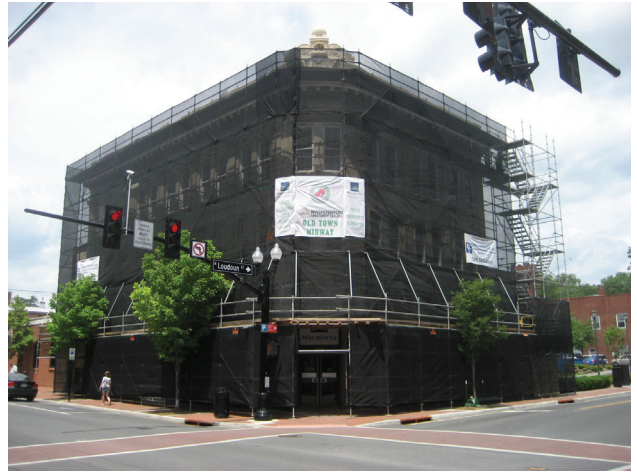
**Primary Resource Description:** This Beaux Arts style bank was constructed circa 1903 at a prominent location at the corner of North Loudoun and West Piccadilly Streets. Entry to the imposing three-story building is located at the intersection of these streets. The bank was undergoing rehabilitation during 2010-2011 survey, and visibility of the façade was obscured as a result. Set on a raised solid stone foundation faced with rock-faced ashlar, this masonry structure is constructed of pressed brick at the second and third stories of the south and east (façade) elevations. Its roof (not visible from the public right of way) is embellished with a stone entablature featuring dentils, modillions, and rosette panels at the underside of the overhanging eave.

The curved, southeast corner of the building holds the main entry, marked by a canted, double-leaf metal and glass door with blind transom and "Wachovia" sign. A secondary entrance is set on the south elevation; it is marked by a single-leaf metal and glass door with sidelights and a blind transom, topped by a half-round fixed light window with an ogee molded arch and volute keystone. Large, fixed wood windows topped by a half-round fixed light extend across the first story of the south and east elevations. Giant order, Corinthian pilasters define each bay of the first story. A molded stone architrave separates the first story from the second story above. The second and third stories have identical fenestration of 1/1, double-hung wood sash windows with stone sills and keyed lintels; these windows extend across the south and east elevations as well as the southeast rounded corner. The second and third stories of the bank's rear (north) elevation are fenestrated with 1/1, double-hung wood sash windows with stone sills and lintels.
