Architectural Analysis of

Godfrey Miller House
422-424 S. Loudoun St.
Winchester, Va.

Douglass C. Reed
Architectural Conservator

Historic Structures Report

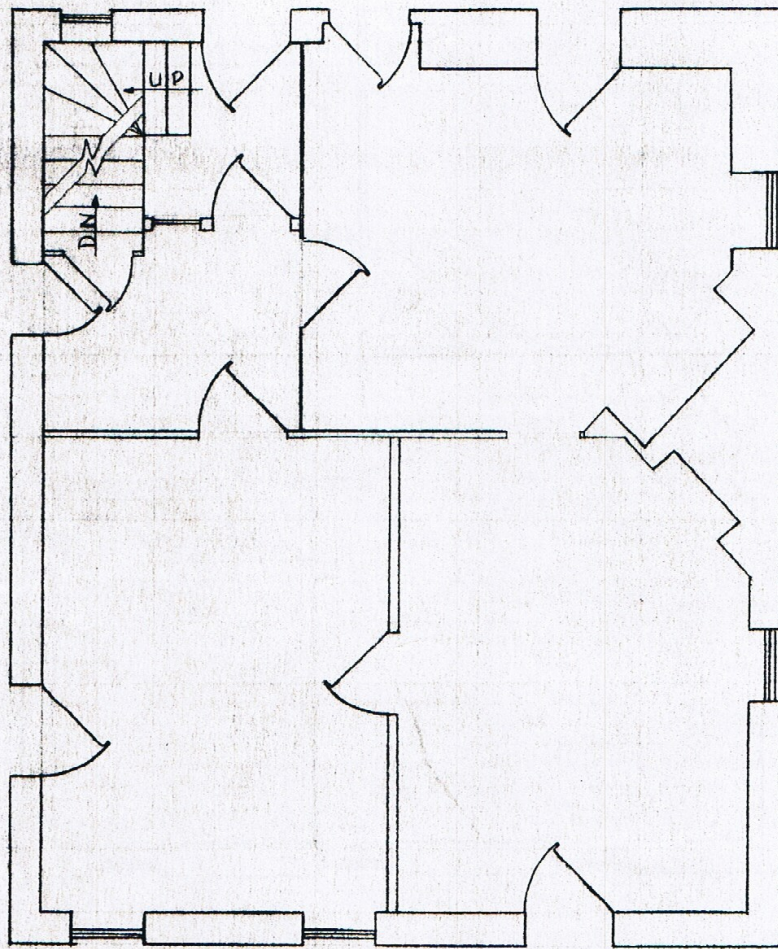
EXISTING FIRST
FLOOR PLAN
MAR 1, 1980

DRAWN BY RESTORATION CONSULTANT DOUGLASS C. REED

SCALE:
3/16" - 1'

GODFREY MILLER
HOUSE

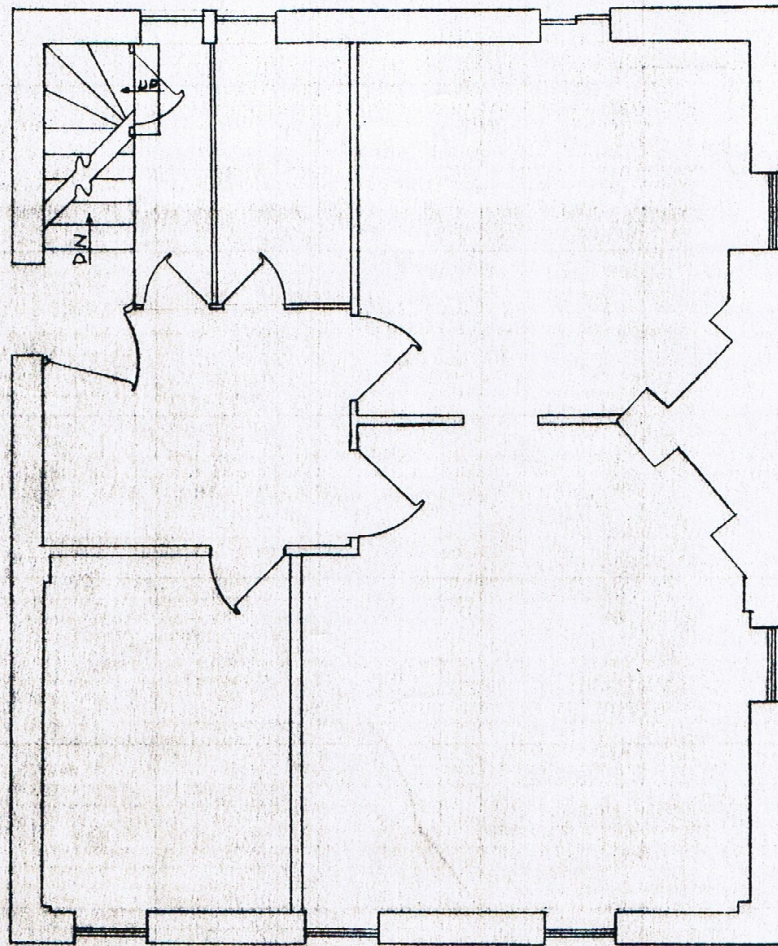
EXISTING SECOND
FLOOR PLAN
MAR. 1, 1980

DRAWN BY RESTORATION CONSULTANT DOUGLASS C. REED

SCALE
 $\frac{3}{16}'' = 1'$

GODFREY MILLER
HOUSE

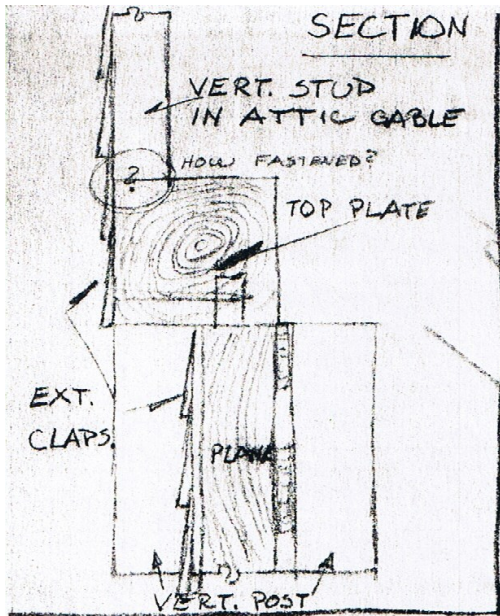
TOP-NORTHEAST CORNER

GODFREY MILLER

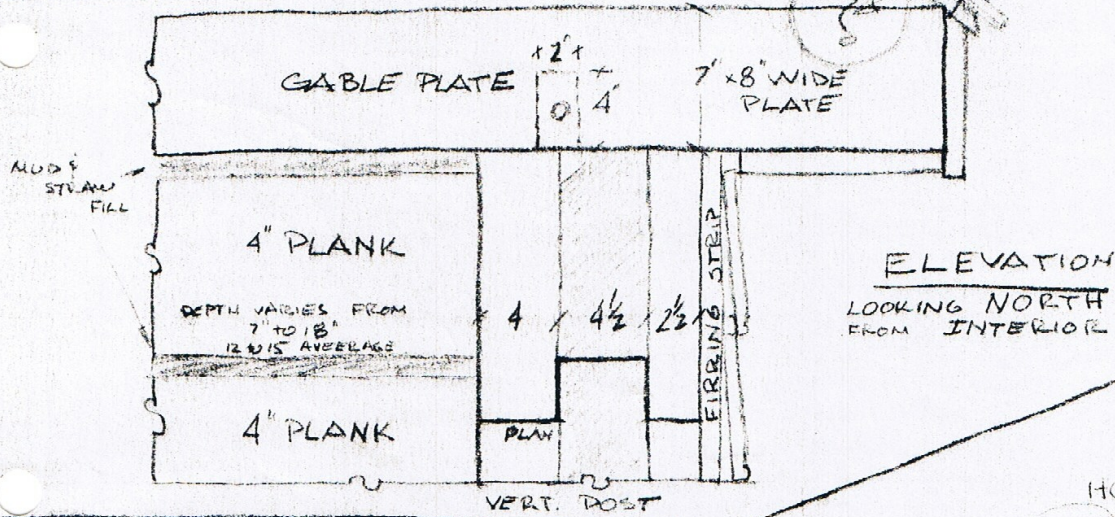
DOUBLE BEVEL OAK
SIDE LAP SHINGLES
12" to 15" EXPOSURE

HOW FASTENED?

HOW FINISHED?

* ALL OAK
