202 East Piccadilly Street

DHR Resource Number: 138-0042-0927 Resources: 1 commercial building

Date/Period: ca. 1910 Style: Vernacular

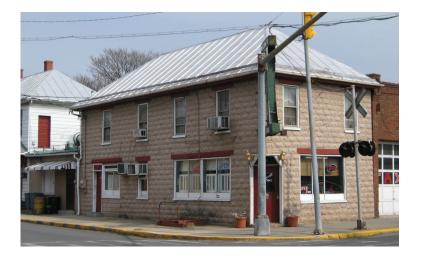
Primary Resource Description: This two-story commercial building has a rectangular plan and is set on a solid concrete-block foundation. It is two bays wide and three bays deep. The masonry structure is constructed of rock-faced, concrete blocks and is capped by a hipped roof covered in standing-seam metal. The roof features overhanging eaves and an interior brick chimney. The main entrance is inset at the southwest corner of the building. The single-leaf entry holds a paneled wood door with one light and features a one-light transom. The second story of the façade (south elevation) and west (side) elevation of the commercial building is fenestrated with 2/2, double-hung, wood-sash windows. The façade and west (side) elevation is also fenestrated on the first story with paired one-light fixed windows with transoms and a row of four one-light, fixed windows. A small window opening on the first story of the west (side) elevation is partially obscured by an air-conditioning unit. Another air-conditioning unit, located immediately to the north, pierces the wall. All windows are enclosed with square-edged wood surrounds and feature rock-faced lintels. A single-leaf entry with a wood door is located in the northern end of the west (side) elevation. It features a bind transom and has a square-edged wood surround. A shared, rock-faced lintel connects the entry with a paired one-light, fixed window with narrow one-light transom.

A one-story, two-bay addition, constructed circa 1930, is located on the north (side) elevation. Constructed of concrete blocks, the addition is capped by a shed roof covered in metal. The west (front) elevation of the façade is fenestrated by a double-leaf entry and a single-leaf entry. Both entries have flush wood doors and are protected by a single, metal awning.
