# City of Winchester

## 401-403 South Kent Street

DHR Resource Number: 138-0042-0556

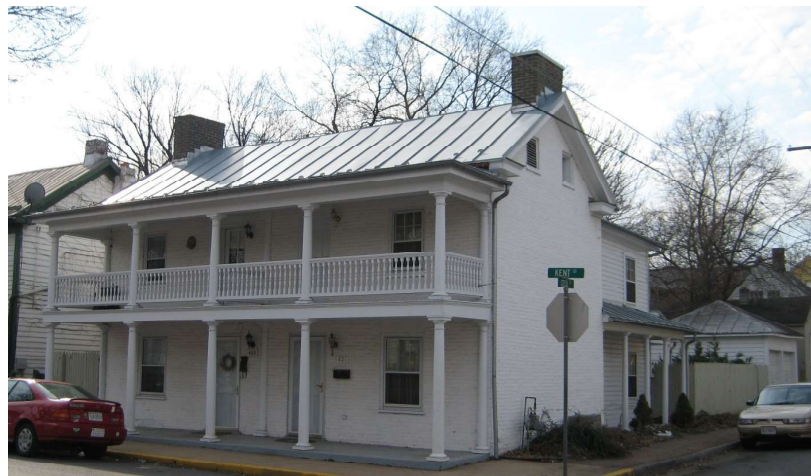
**Primary Resource Description:** This two-story twin dwelling or double house consists of two single-family dwellings, each two bays wide. Rectangular in form, this twin dwelling is set on a solid foundation of five-course, American-bond brick and is constructed of five-course, American-bond brick that has been painted. Two interior-end brick chimneys pierce the side-gabled roof, which is covered in standing-seam metal. The roof is finished with cornice returns, boxed cornice with ogee molding, and overhanging rake. The window openings on the façade contain 6/6, double-hung, wood-sash windows with ogee-molded wood surrounds. The twin dwellings are accessed by single-leaf, paneled wood doors (located in the center two bays) that have metal-frame glass storm doors. The upper gable ends of the side elevations have two openings that contain louvered wood vents flanking the interior chimney stack.

A two-story, full-width porch (four bays wide), constructed circa 1920, stretches across the façade. It has a half-hipped roof supported by Tuscan wood columns and pilasters. The second story of the porch has turned balusters.
