703 South Loudoun Street

DHR Resource Number: 138-0042-0814

Date/Period: ca. 1850 Style: Federal

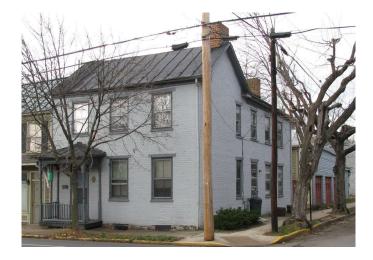
Primary Resource Description: Constructed circa 1850, this two-story, three-bay Federal-style single-family dwelling is set on a solid random rubble foundation. The building is constructed of irregular-coursed, American-bond brick. Standing-seam metal covers the sidegabled roof, which is accented by a corbeled brick cornice and cornice returns. An interior-end brick chimney rises from the north (side) elevation and has a plain cap.

A single-leaf, paneled wood door is located in the southernmost bay of the façade (east elevation) and is surmounted by a four-light wood transom. A one-story, one-bay porch shelters this entry and is set on a wood post foundation. The half-hipped roof is covered with standing-seam metal and is supported by turned wood posts. Jigsawn brackets, pendants, and square wood balusters embellish the porch. Additional openings on the façade hold 2/2, double-hung, wood-sash. Openings are accented with wood sills and wood lintels. The foundation is pierced by wood awning windows.
